FINAL REPORT
INVESTIGATION AND IMPROVEMENT OF THE
RELIABILITY OF THE C-141A AIRCRAFT
MASTER CAUTION CONTROL UNIT

JULY 1976

ARINC RESEARCH CORPORATION

D. Dahl

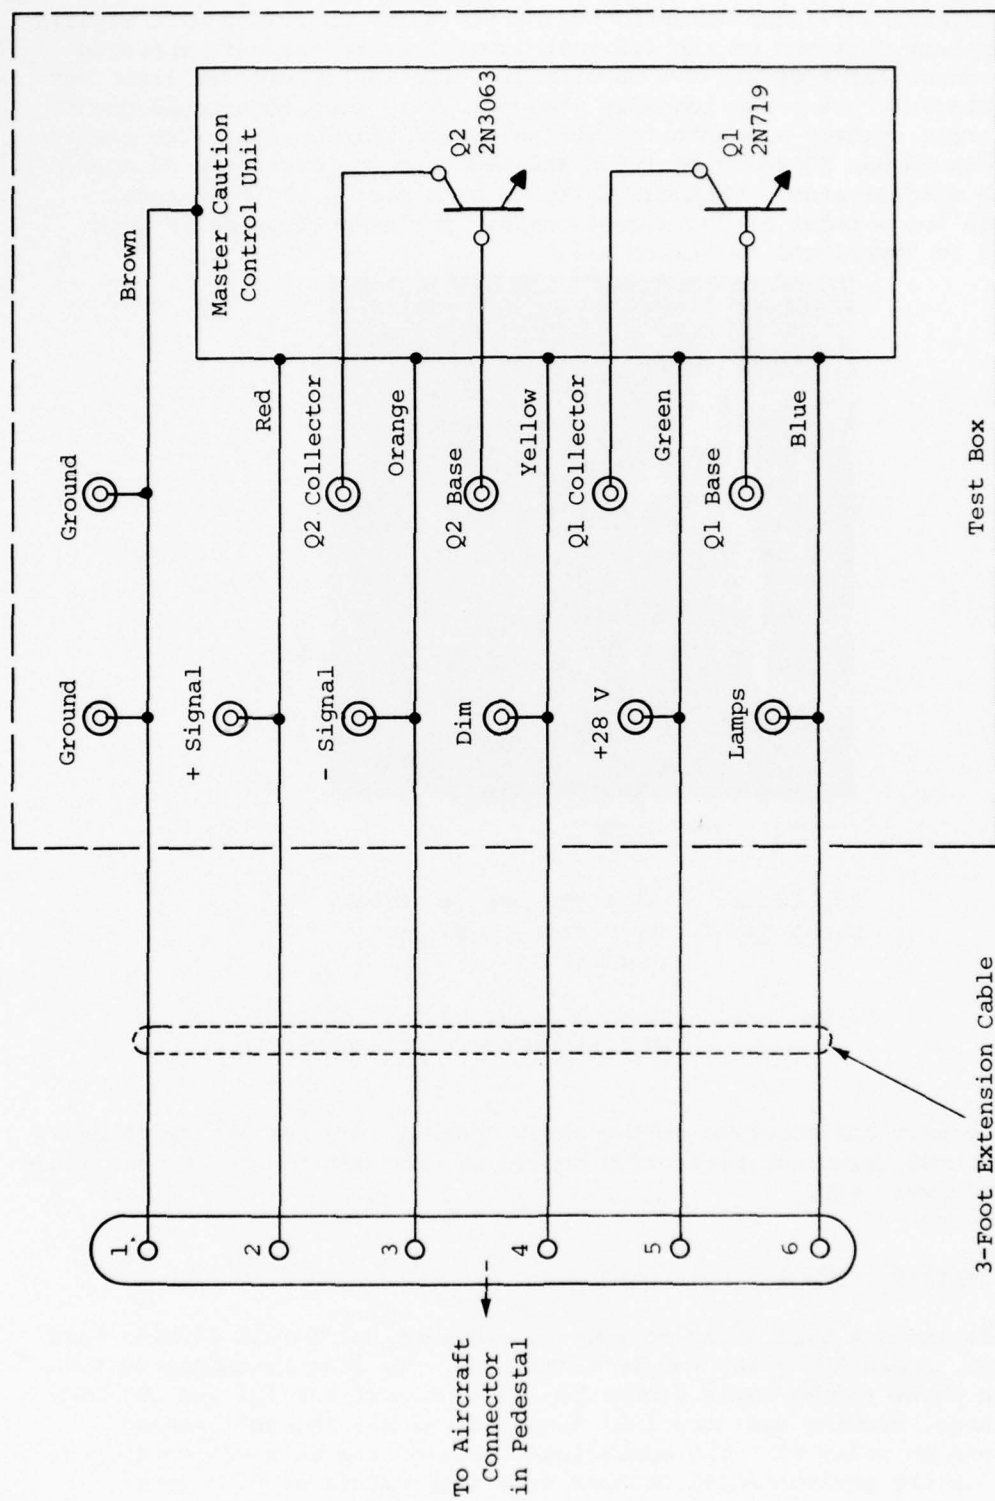
Figure 3-1. SPECIAL TEST FIXTURE FOR AIRCRAFT MEASUREMENT

For this effort, we built a special test fixture (see Figure 3-1) designed to plug into the aircraft MCCU connector. With this fixture, it was possible to monitor all input lines to the MCCU, as well as the collector and base terminals of both transistors in the unit. Utilizing aircraft power, we made aircraft measurements with a dual-trace portable storage oscilloscope (Tektronix Type 466) in conjunction with the test fixture.

The peak detectors recorded both positive and negative transient spikes with amplitude between 200 volts and 400 volts at the input to the positive channel of the MCCU. These peaks occurred when the caution control reset switch was actuated the first time to clear the flashing annunciator displays, following the application of aircraft power.

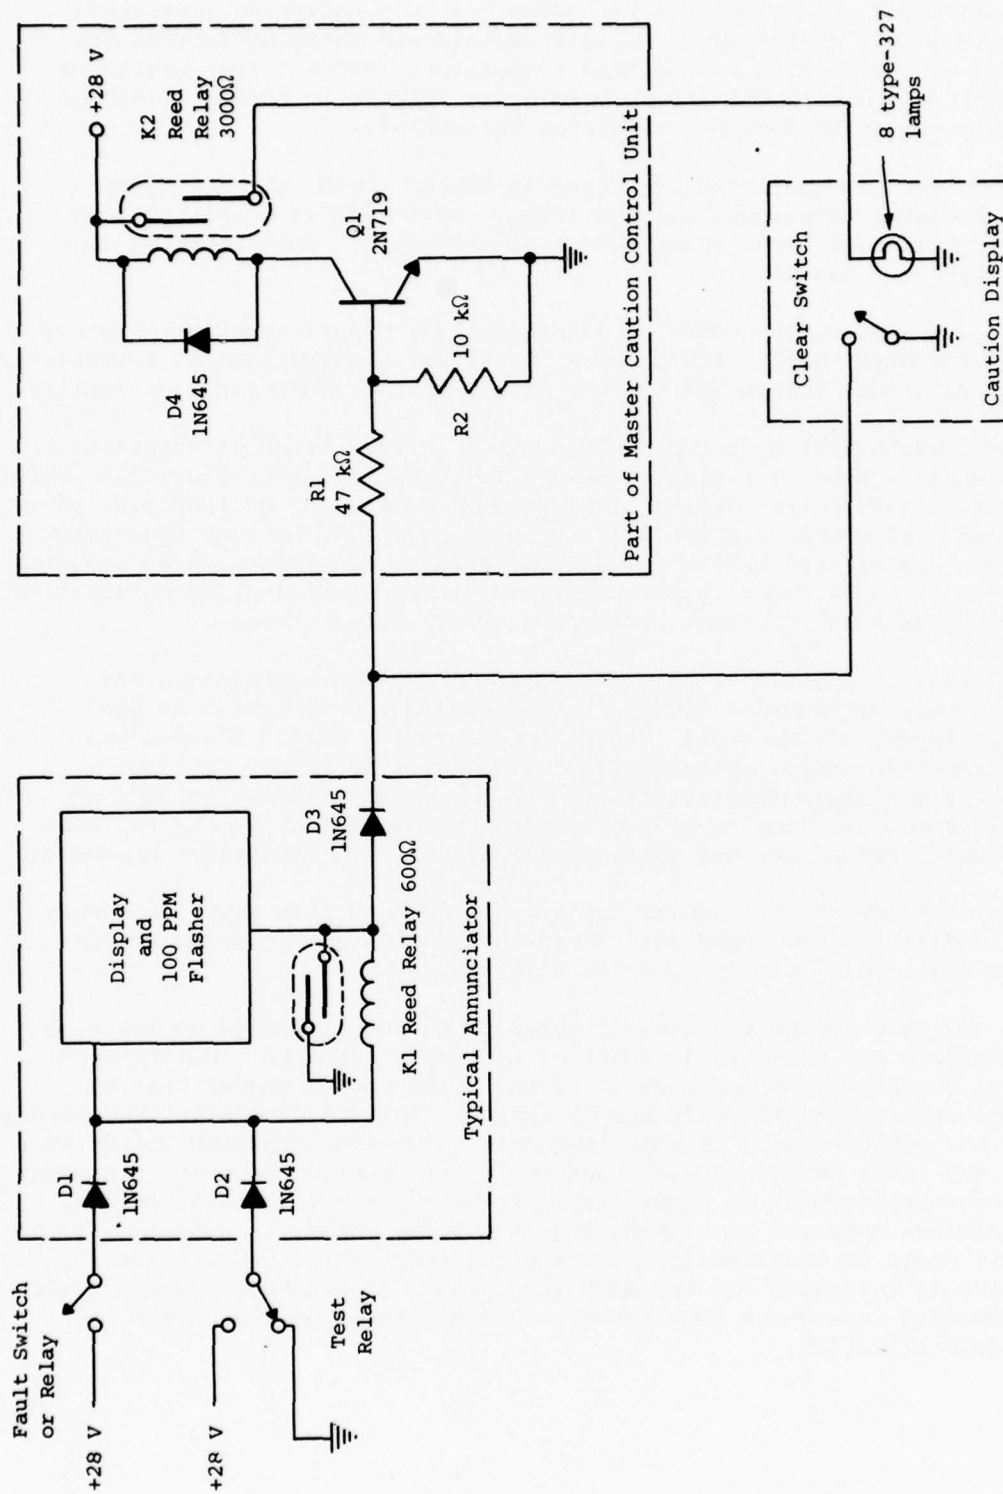
Figure 3-5. POSITIVE CHANNEL, CAUTION WARNING SYSTEM

Figure 3-5 is a simplified diagram of the positive channel. RFI filters and dimming circuits have been deleted for clarity, and only one channel is shown. (The negative channel functions in essentially the same way except for its reversed polarities and the use of a 2N3063 PNP transistor in the MCCU.) The functions of the various circuit elements are described in the following paragraphs.

To clear the master caution display, the pilot or copilot "clear" switch is energized. This grounds the input to the MCCU and also energizes K1. When K1 is energized, it latches and switches the annunciator from a flashing to a steady display, removing the +28 volt input signal to the MCCU. Transistor Q1 turns off, relay K2 deenergizes, and the MCCU is then free to respond to a new annunciator (fault) signal. Diode D4, which is connected across relay solenoid K2, provides transient protection for Q1 at turn-off. There are 14 positive annunciator channels connected in parallel to the MCCU (there are also 36 negative channels).
